Workhorse Custom Chassis Service Bulletin

Bulletin Number: 50902-I

Subject: Safety Recall 50901-C Interim Repair Procedure

**Models: All W20, W21, W22 Models Produced from July 24, 2000,
through December 19, 2007, and Equipped with Bosch ZOPS
or ZOHT Hydraulic Disc Brake Assemblies**

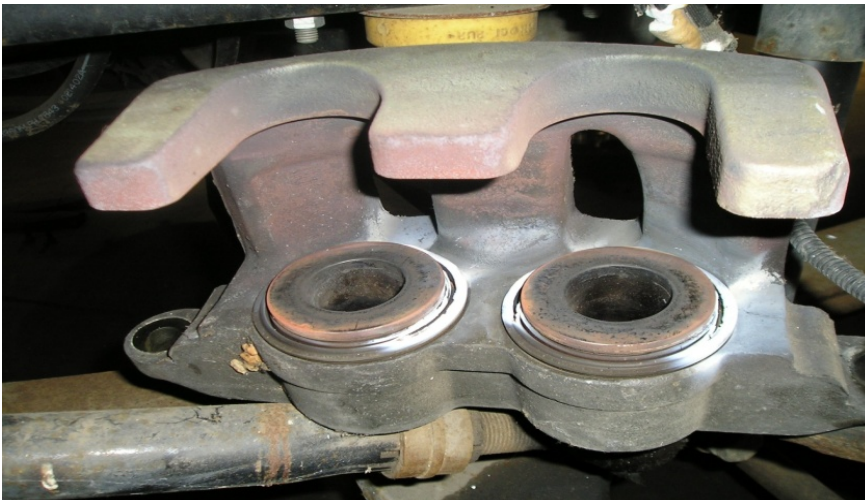
- **White residue on the piston dust seal/boot and caliper**

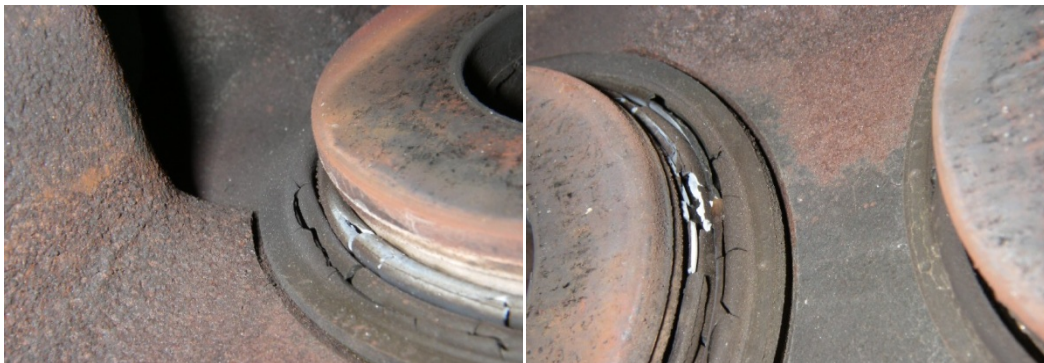
- **Cracked piston dust seal/boot (white residue may also be present)**

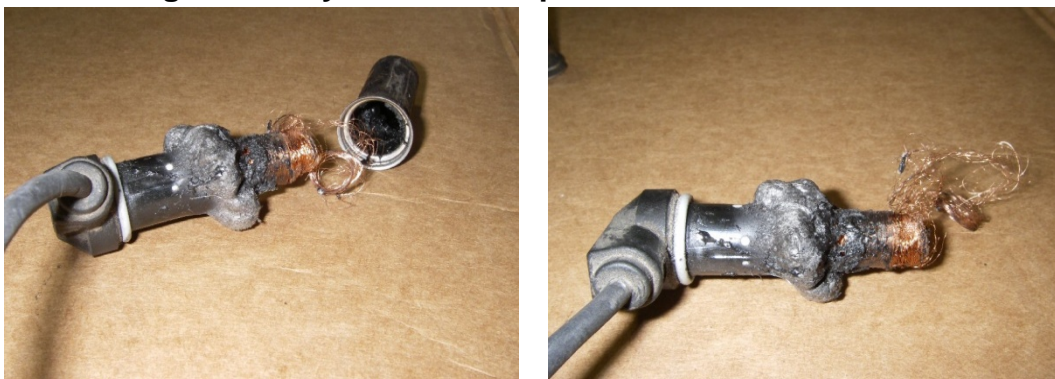
- **Heat damaged ABS system wheel speed sensors**

ABS sensors experiencing heat damage that may be related to the safety recall have stopped functioning at various speeds and may have intermittent or complete loss of functionality and associated fault codes.

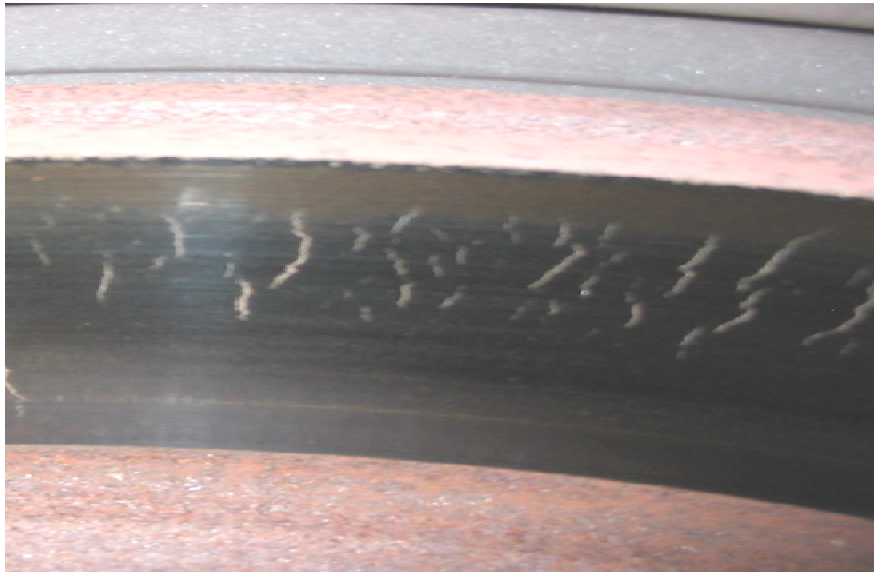
- **Short radial cracks on the rotor surface that comes into contact with the brake pads (“heat checking”) is caused by heating and cooling of the disc during normal operation. No corrective action or replacement is required.**

The existence of cracked rotors as described above, and without any other evidence (see additional items described below), would not justify a caliper replacement per the interim letter – neither would the replacement of the rotor qualify for a goodwill policy replacement. A replacement of the rotor under these conditions would be the responsibility of the customer.

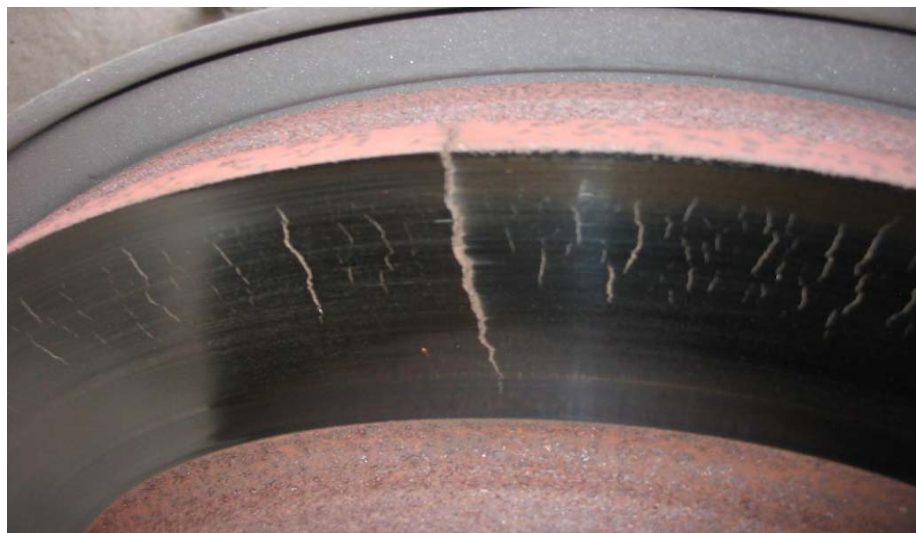
- **A rotor with a large radial crack that has migrated through the outer surface, as shown below, will need to be replaced.**

Again, without any other evidence of damage that may be related to the safety defect, the replacement costs for this condition would be the responsibility of the customer.

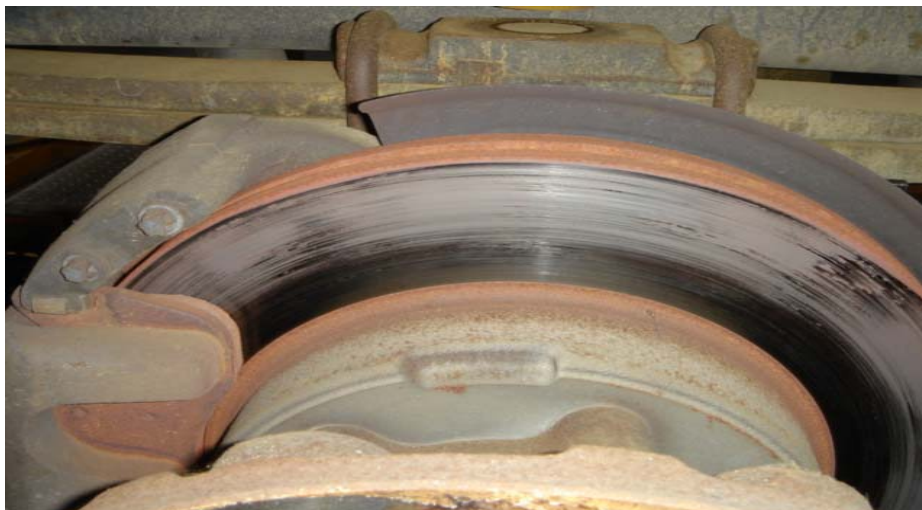
- Rotor colors vary from vehicle to vehicle. The rotor below shows some normal discoloration and light transfer of brake pad material. If necessary, the rotor may be machined during a related interim repair but does not require a mandatory replacement. Rotor thickness will have to be measured to verify it is within the specified minimum thickness prior to turning.

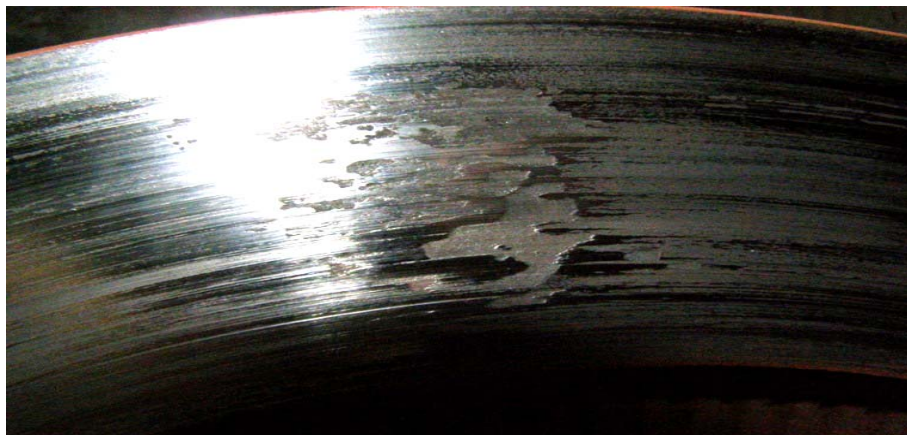
The rotor shown below exhibits severe brake pad material transfer and is a good indicator that the brake caliper assembly at this wheel end had experienced brake drag that may be related to the safety defect. The excessive amount of brake pad material transferred on to the rotor would be considered collateral damage and will require the replacement of the rotor. The associated cost is covered by the interim repair procedure if a caliper failure has occurred.

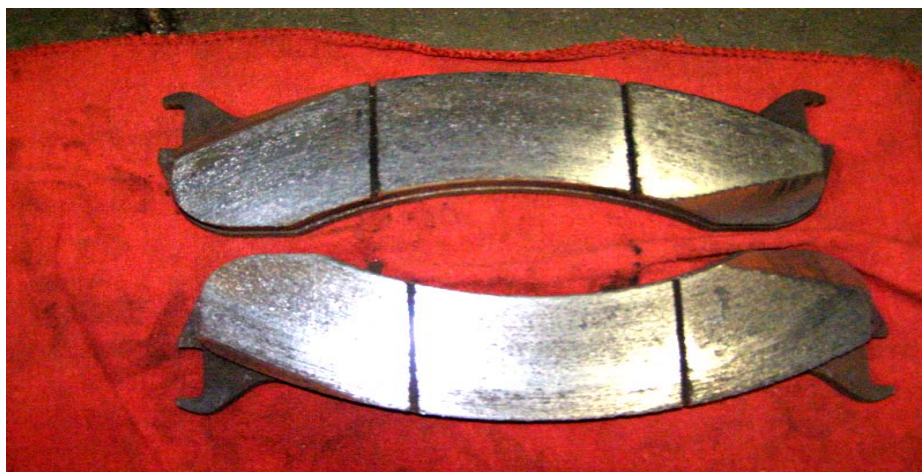
- Pads below show normal brake pad wear noted by a smooth surface with no resin or material transfer from the pad. No repair action is required.

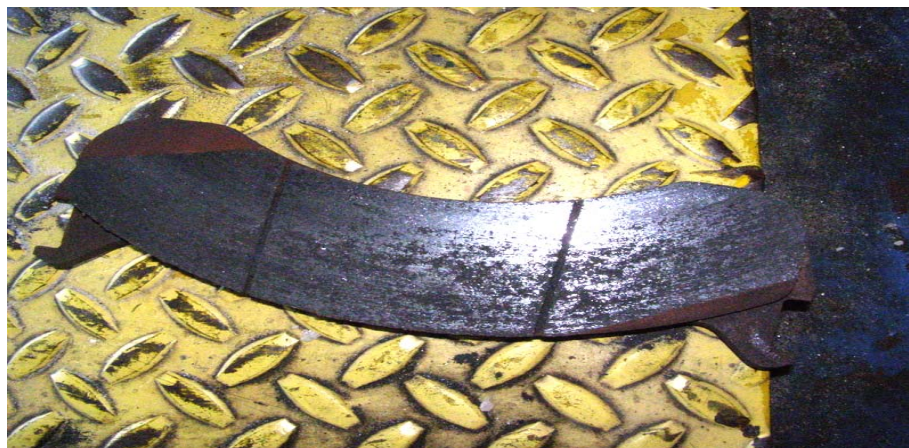
- The brake pad shown below exhibits the rough/damaged surface typically associated with material transfer from the pad to the rotor due to excessive heat. The corresponding rotor will most likely exhibit corresponding material deposits from these pads. Replacement of a brake pad in this condition is considered collateral damage and is covered by the interim repair procedure.
